Erosion and Restoration of Two Headwater Wetlands Following a Severe Wildfire

Jonathan W. Long and Javis Davis

ABSTRACT

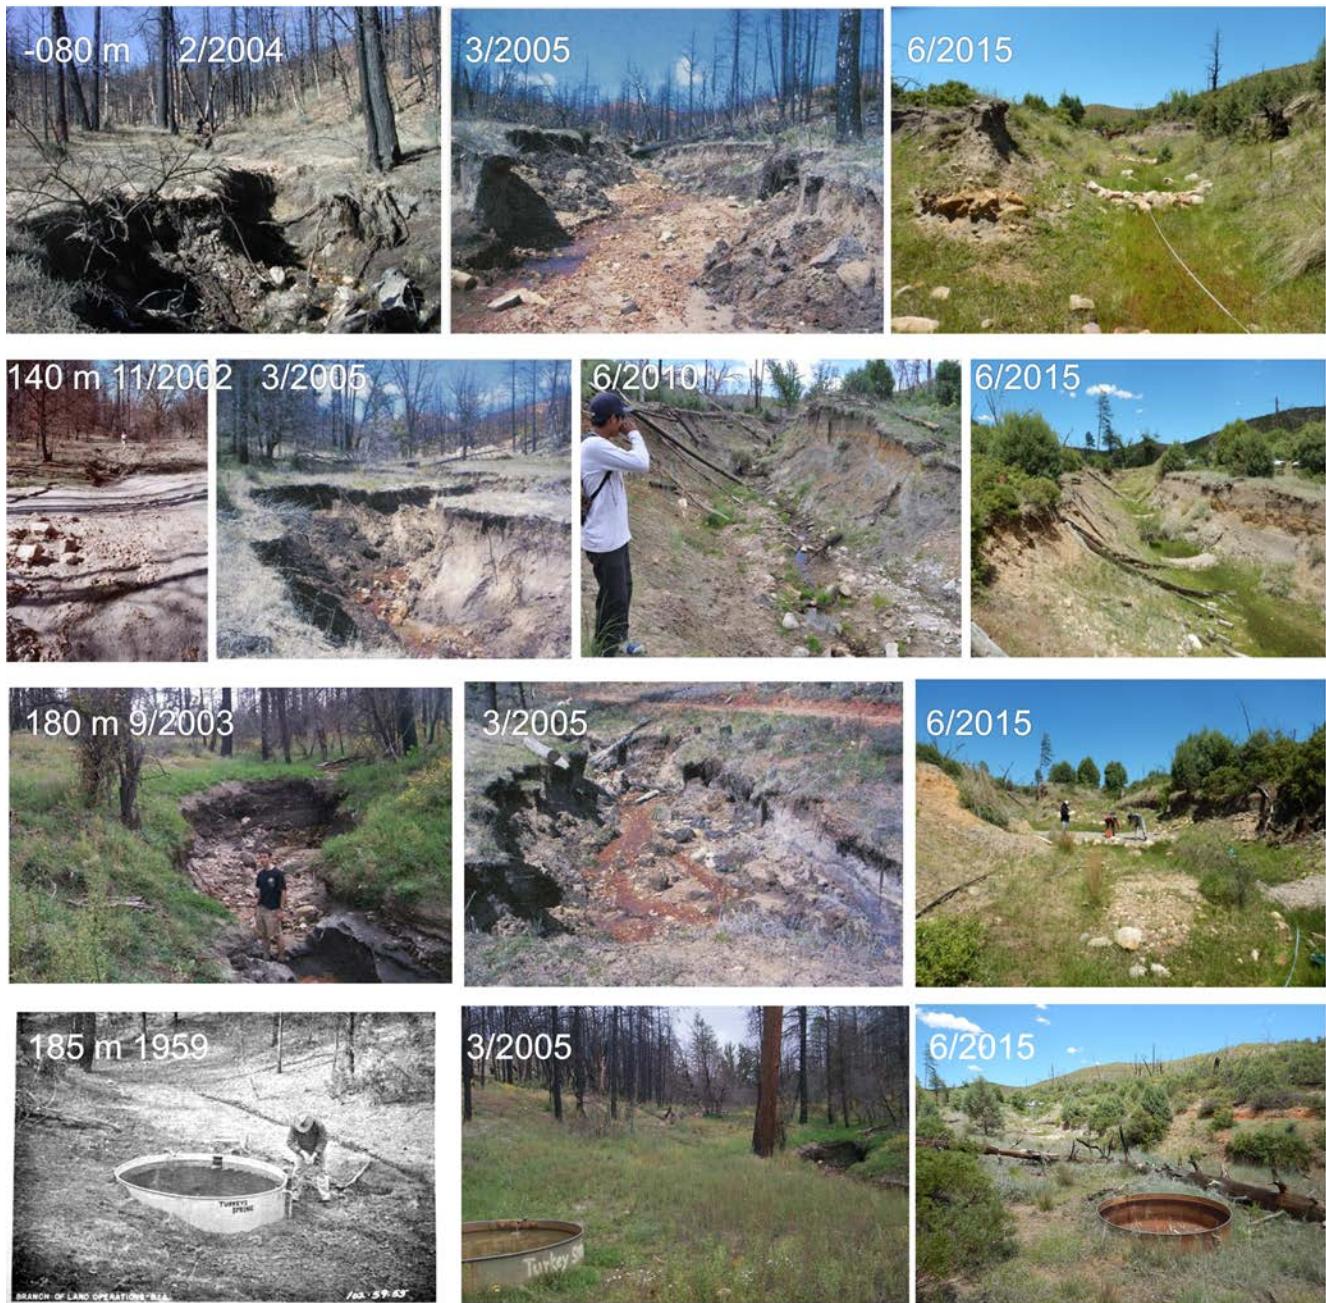
Figure 2. Repeated photo points at Turkey Spring, Arizona, U.S. The top three rows of photopoints depict headcutting at three major nickpoints after the fire in 2002. The photo from November 2002 shows that channel incision was not yet continuous, but flows were moving very large rocks. Photos from 2003 to 2010 show that the channel deepened by over 4 m. Subsequent channel widening combined with placement of riffle formations in 2004 facilitated regrowth of vegetation by June 2015. The bottom row of photos shows a narrow, unincised channel next to a livestock watering drinker installed in 1959 (photo courtesy of Bureau of Indian Affairs, Branch of Land Operations). By September 2003 (photo taken from a slightly different angle), the channel had incised to the point that it was longer visible from this location.

involved placement of heterogeneous mixtures of gravels and cobbles, reinforced with *Carex* (sedge) transplants (Medina and Long 2004). These formations are comparable to typical loose rock check dams; however, the formations are longer than typical checkdams and rely on the incorporation of the vegetation transplants to bind the materials (Medina and Long 2004). Because they do not include metal posts or gabion baskets, the formations are deformable during high flows. Both sites in this study were proposed for a scaled-up version of the riffle treatment using larger rock materials, even though their watersheds were considerably smaller than those where the technique had been piloted, because the channels were steeper and were moving larger rocks following the fire (Figure 2).

also have contributed to some localized incision before the fire. Furthermore, a photograph of Turkey Spring in 1959 (Figure 2) reveals a narrow (< 1 m) stream of water flowing on the surface of a narrow valley bordered by *Pinus ponderosa* (ponderosa pine) trees, with no indications of channel incision.

Photographs were taken at various locations at Turkey Spring beginning in November 2002 (6 months post-fire) (Figure 2) and Swamp Spring beginning in September 2002 (3 months post-fire) (Figure 5). The extensive erosion complicated photo retakes, but the use of a GPS-enabled camera in more recent years facilitated repositioning. The photos complemented the quantitative survey data by illustrating how vegetation and nickpoints changed. The use of photos taken over time at the same location has been recommended for documenting changes and communicating effects that might easily be missed through in-stream measures of water quality and habitat (MacDonald and Smart 1993). We found only one oblique photo of the channel Turkey Spring prior to the fire, taken in 1959 (Figure 2), and none for Swamp Spring.

which indicate high potential for meadow incision (Chambers and Miller 2011). We included photo sequences that reveal the changes at three such nickpoints at Turkey Spring (Figure 2) and one at Swamp Spring (Figure 5). Channel incision at Turkey Spring was initially discontinuous, with intervening reaches that initially resisted incision due to armoring by gravels and cobbles, tree roots, and the cohesive organic horizons (Figure 2). At Swamp Spring, erosion not only formed steep nickpoints along the main channel but also caused mass wasting of soils from the large wet meadow on the east side of the channel (Figure 5).

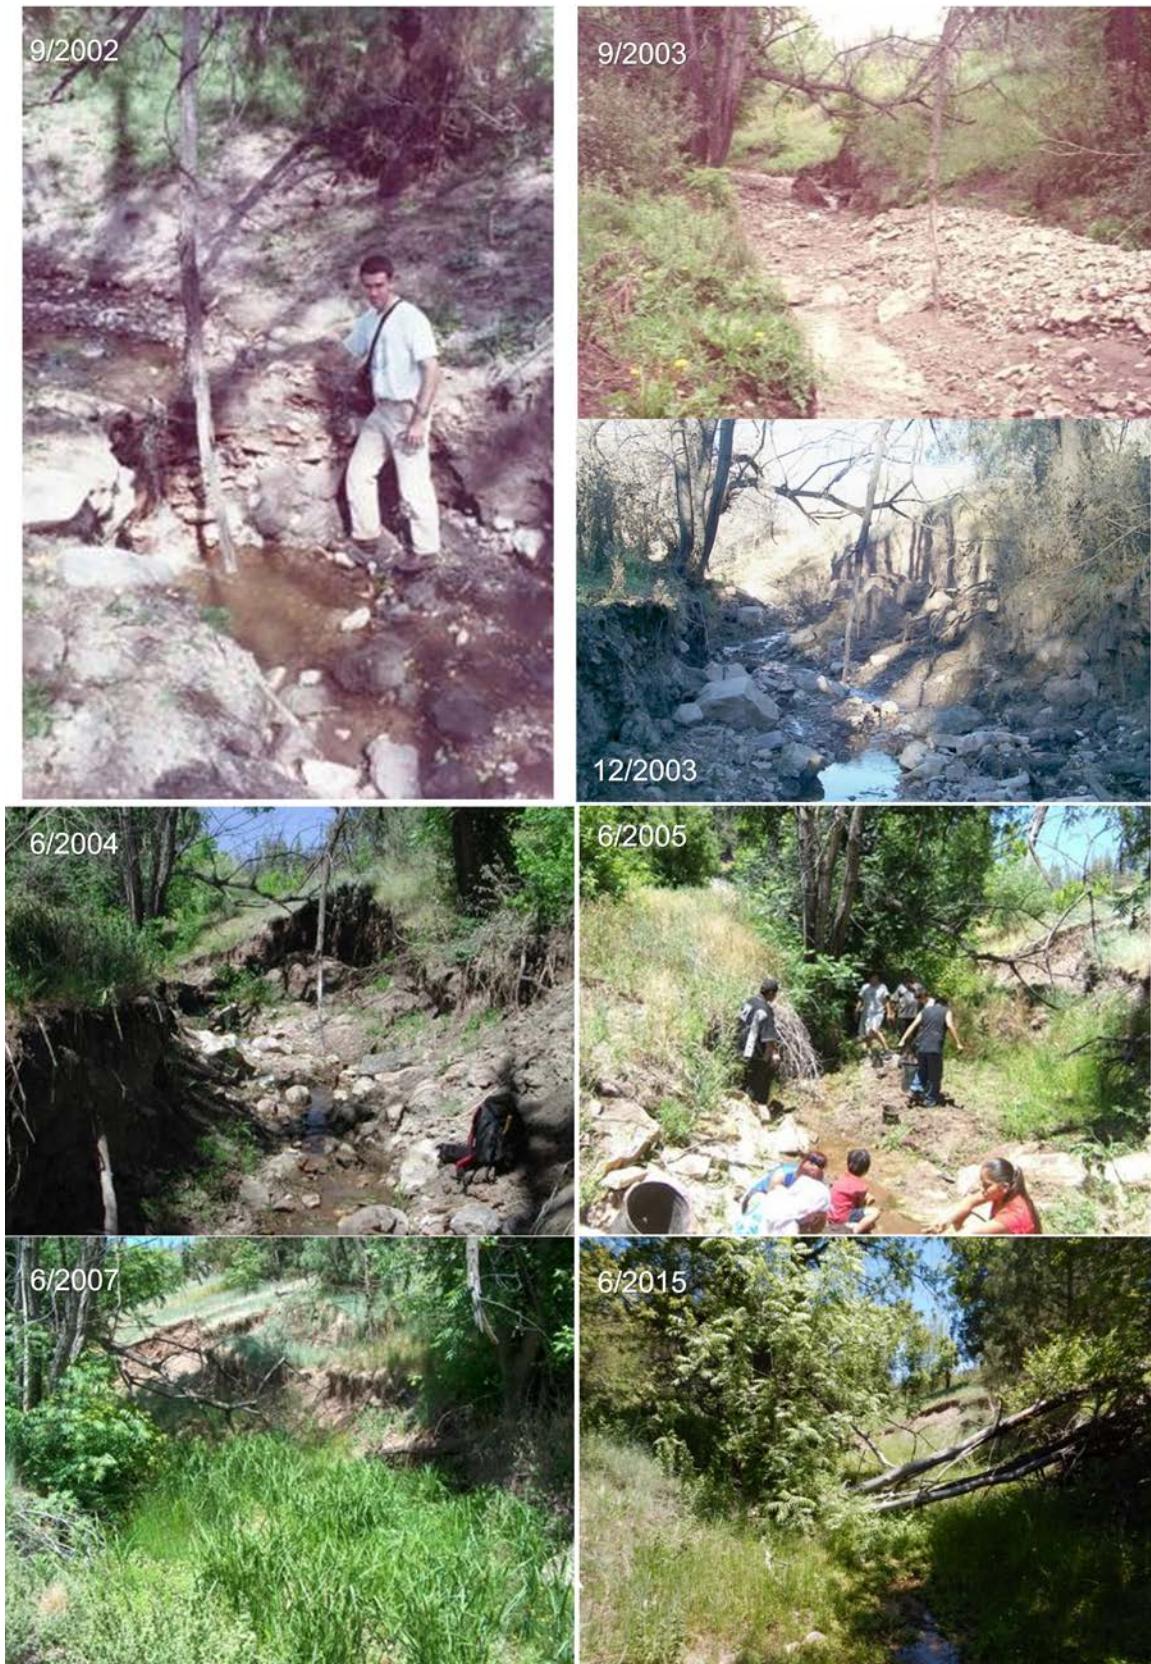
Figure 5. Swamp Spring photo point at 215 m on the surveyed reach, note that the hanging, broken branch at center for reference. In September 2002, there was a 1.5 m high channel nickpoint. In the following two years, the nickpoint migrated upstream, and large chunks of the meadow on the upright were sloughing into the channel. In June 2005, students and volunteers planted *Carex* and *Scirpus* transplants on top of the newly placed riffle formation, which contributed to rapid growth of dense vegetative cover that has persisted.

Swamp Spring. The placement of rock formations along the channel (Figure 5) in 2015 reduced the channel area at the cross-sections (Figure 7), particularly in the upper part of the reach where one of the largest rock formations was placed. Since the treatments, the channel cross-sections have shown minor changes, indicating that they have remained stable.

Repeat photographs of the Swamp Spring site (Figure 5) revealed rapid recolonization of the stream channel following treatment in 2005. The most significant changes were growth of wetland and aquatic vegetation, including grass-like plants, aquatic forbs, and algae, as well as associated litter. Meanwhile, the very high amount of exposed hardpan present prior to treatment was replaced by other cover types in the 2009 survey (Table 3).
